Ecological site R022BI215CA Frigid Gravelly Flood Plains

Provisional. A provisional ecological site description has undergone quality control and quality assurance review. It contains a working state and transition model and enough information to identify the ecological site.

Major Land Resource Area (MLRA): 022B–Southern Cascade Mountains

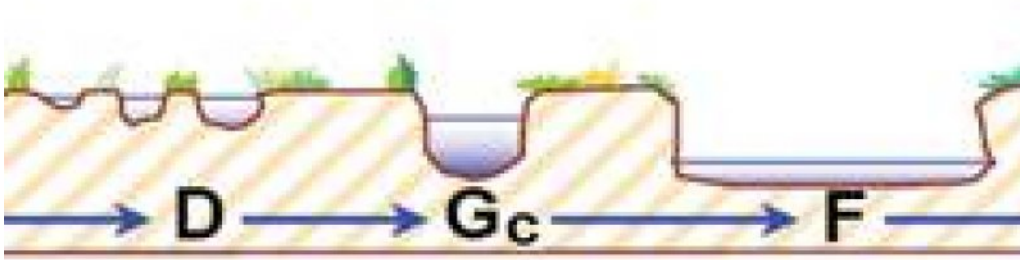
Figure 3. Rosgen Stream Succession Scenario 3

The Rosgen Stream Succession Scenario #3 above displays a possible channel evolution pathway for this site. Sections of this site are presently braided exhibiting a “D” type channel. However, stream classification data is needed to determine the actual stream evolution process occurring on this site. Braided “D” channels are unstable systems, with poor lateral bank stability. They tend to carry large amounts of bedload gravels and cobbles. The constantly moving channels make it difficult to design stream crossings or implement restoration. When flow begins to concentrate into a main channel a “D” channel may evolve into a “Gc” type channel. A “Gc” type channel is an unstable, gully-like, entrenched channel which will naturally begin to widen over time into an entrenched “F” type channel. The broadly entrenched “F” type channel allows for sediment deposition, which builds point bars and floodplains with a meandering channel. As riparian vegetation begins to reestablish on the new floodplains, channel stability increases, and an entrenched “C” type channel with a developed floodplain and a meandering channel will eventually develop within the entrenched “F” type channel. This new entrenched “C” type channel may resemble the original “C” type channel with wetland plant communities, but it will be constrained by terraces to the lower floodplain area. The old floodplain becomes a terrace, disconnected from flood events. The terrace has a lower seasonal water table which supports a greater proportion of upland plant communities.

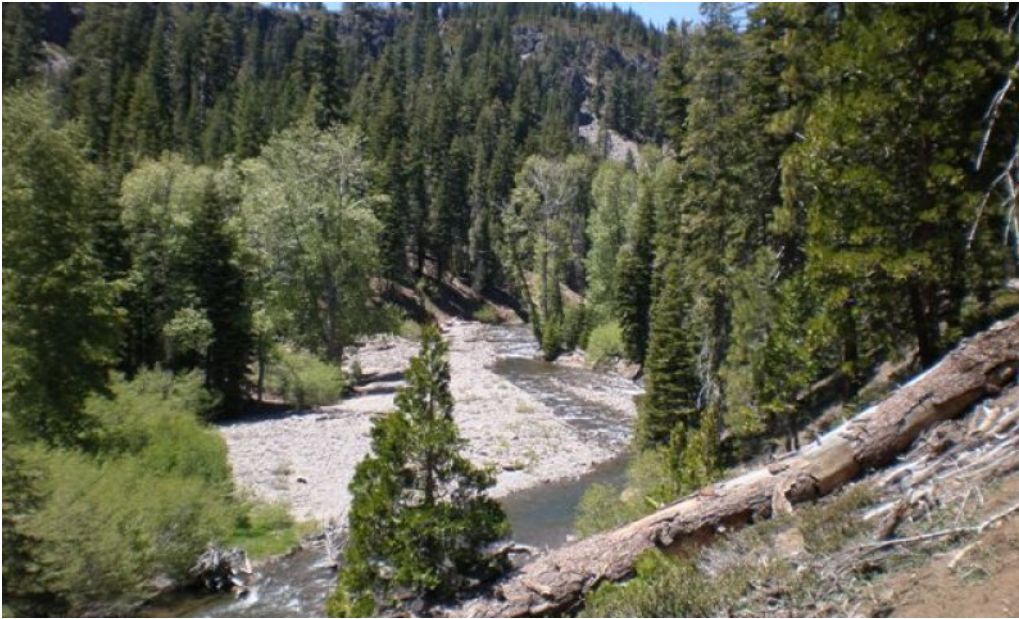
Figure 4. Gravelly Flood Plains, Kings Creek

This C Channel has re-established a floodplain and natural sinuosity. It is constrained by the old flood plain, which is now a hydrologically disconnected terrace.

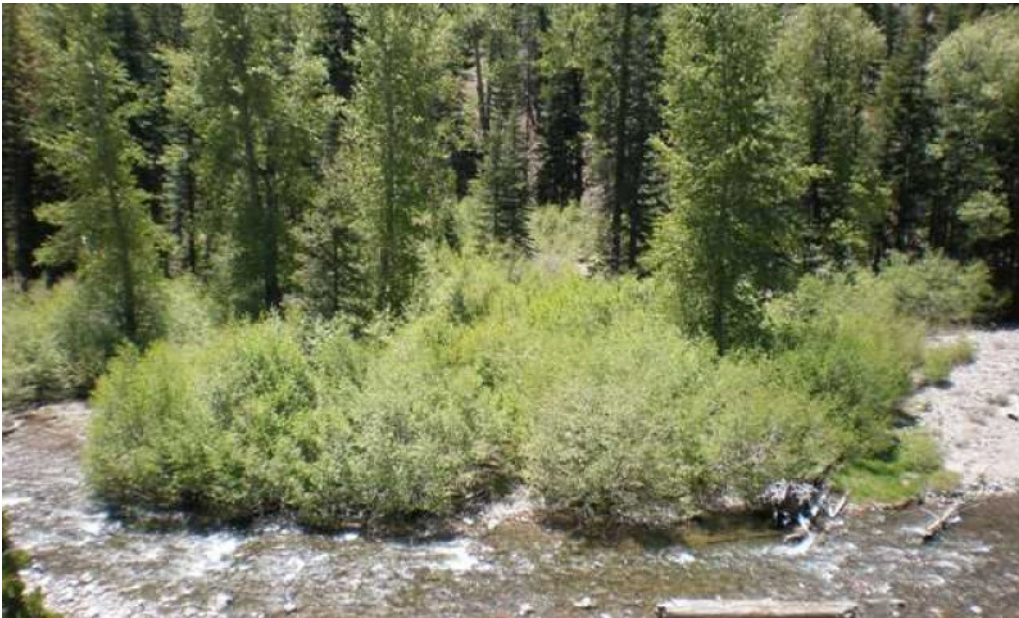
Figure 5. Gravelly Flood Plains

The composition of the plant communities has shifted primarily, because the stream channel incised through deposits creating a terrace with an upland plant community (PCC4). The riparian communities are confined to a smaller area within the new floodplain. In some areas, the sedges associated with the Lemmon's willow- thinleaf alder community (PCC2) have been replaced by grasses because of lower water tables. Non-native species may be present. PCC1b: 20 % Thinleaf Alder- Willow Community This community is found along the stream channel on the banks and relatively stable point bars. Thinleaf alder (*Alnus incana* ssp. *tenuifolia*) dominates this community with Lemmon's willow (*Salix lemmonii*), and shining willow (*Salix lucida*) present in smaller amounts. Within the patches of shrubs the canopy cover is dense with little understory. However, along the channel or in canopy openings fringed willowherb (*Epilobium ciliatum*), seep monkeyflower (*Mimulus guttatus*), purple monkeyflower (*Mimulus lewisii*), bugle hedgenettle (*Stachys ajugoides*), American vetch (*Vicia americana*), bluejoint
